FIRE TESTING OF INDEPENDENT FIBERGLASS  
FUEL TANKS WITH AND WITHOUT PROTECTIVE  
COATING OF FIRE RETARDANT PAINT

UNITED STATES COAST GUARD  
OFFICE OF RESEARCH AND DEVELOPMENT  
APPLIED TECHNOLOGY DIVISION

LTJG J. D. RICHART, USCG  
MERCHANT MARINE TECHNICAL DIVISION  
OFFICE OF MERCHANT MARINE SAFETY

Date: 2 July 1971  
Submitted: J. L. Coburn Jr.  
J. L. COBURN, CDR, USCG  
Chief, Marine Safety Projects Branch  
Approved: J. R. Iversen  
J. R. IVERSEN, CAPT, USCG  
Chief, Applied Technology Division  
U. S. Coast Guard Headquarters  
400 7th Street, S. W.  
Washington, D. C. 20591

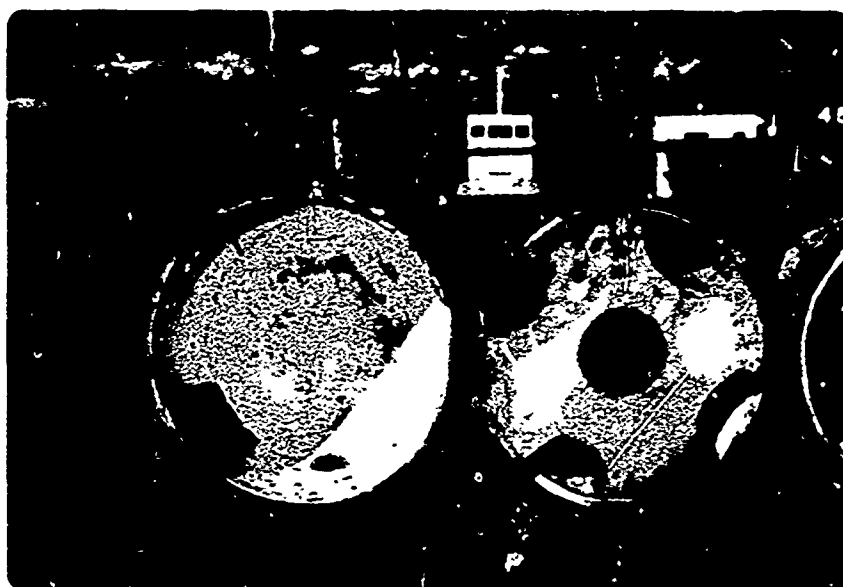
PHOTOGRAPH # 19: Test #6, unpainted tank's internal appearance after fire. Note delamination in right half of tank.

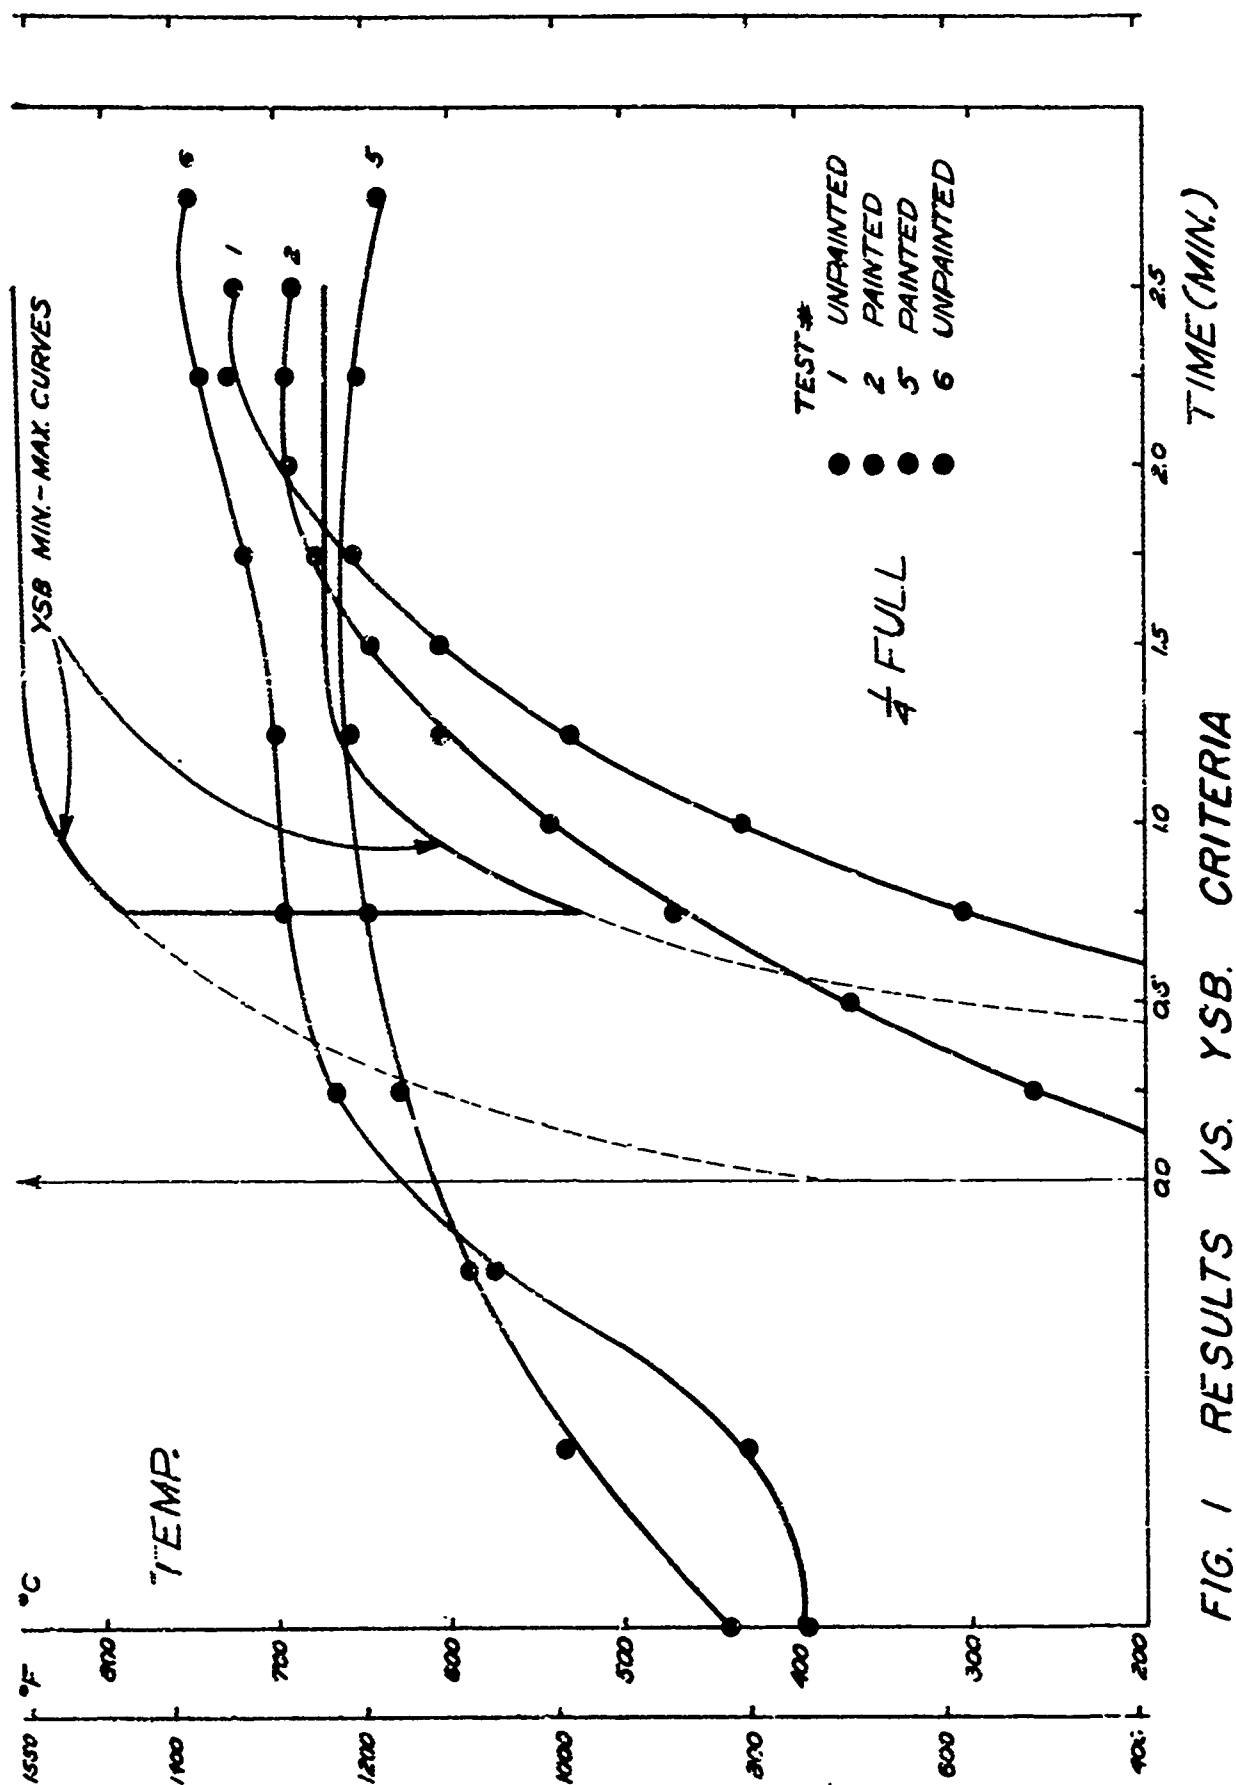
FIG. 1 RESULTS VS. YSB. CRITERIA

FIG. 1 shows that Test #6 on the unpainted tank had temperatures which fell easily between the YSB's min.-max. curves for the 2m30s independent fuel tank fire test. Test #5 did not cross over the minimum curve, due to variables beyond control. As can be seen in FIG. 5, the unpainted tank was subjected to a fire about 150°F hotter than the painted tank. However, the painted tank lasted two minutes longer and still presented a better internal appearance. The internal temperatures depicted on FIG. 7 show the temperature in Test #6 to rise sharply after two minutes. The dip in the curve can be explained as follows: the thermocouple was positioned in the vapor space and when the fuel began to boil, a droplet of fuel hit the nickel bead, causing a sharp drop in temperature reading. As the liquid vaporized, the temperature again climbed rapidly.
